# Manhole Inspection Summary

Manhole # S2900\_011MH

Insp Date: **6/25/07 8:39 AM**

**Location** Address: **2601 FALLS RD**

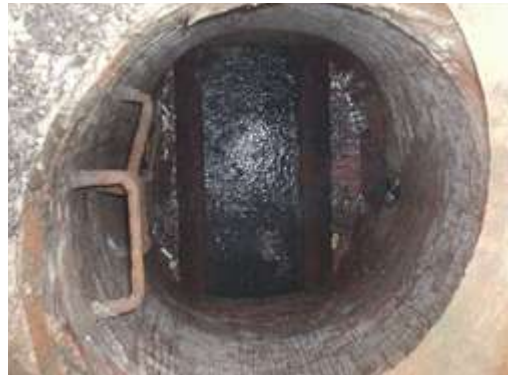
Top View

Corroded steps. Evidence of surcharge - Bench debris. Channel debris.

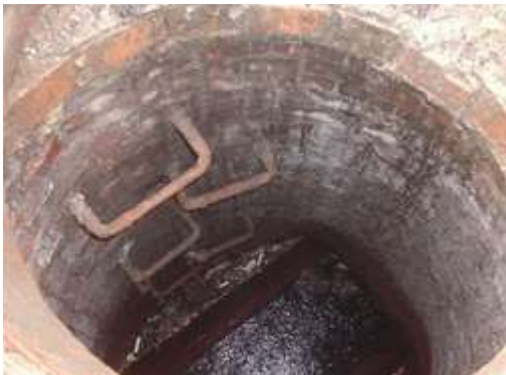
Defect

Frame leaks. Adjustment and Corbel infiltration - other side.

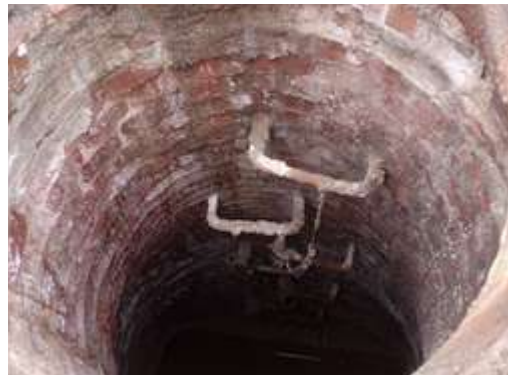
Defect

Frame leaks. Adjustment and Corbel infiltration.

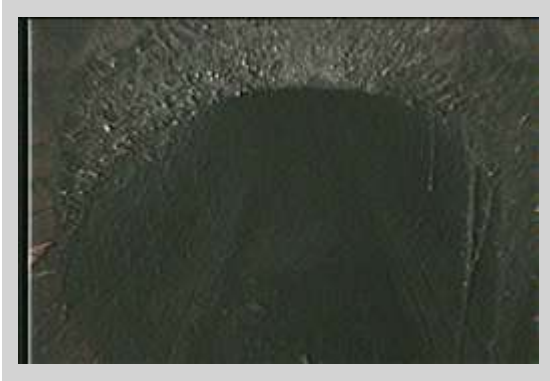
### 27 in. Circular Gravity Sewer Pipe Out @ 12 O'Clock

Deposits: ☐ None ☒ **Mud** ☐ Sludge ☒ **Debris** ☐ Grease

Silt Depth: **2** (in.) Deposits Extent: **Light**

Infiltration: **Evidence** Pipe Seal Cond: **Roots**

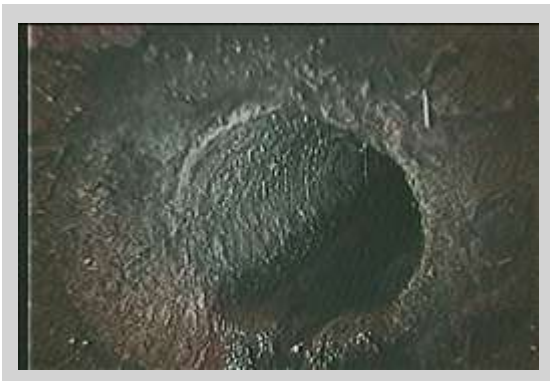
### 8 in. Circular Gravity Sewer Pipe In @ 4 O'Clock

Infiltration: **None** Pipe Seal Cond: **Roots**
